EXECUTIVE SUMMARY

Granite Lake, Stoddard

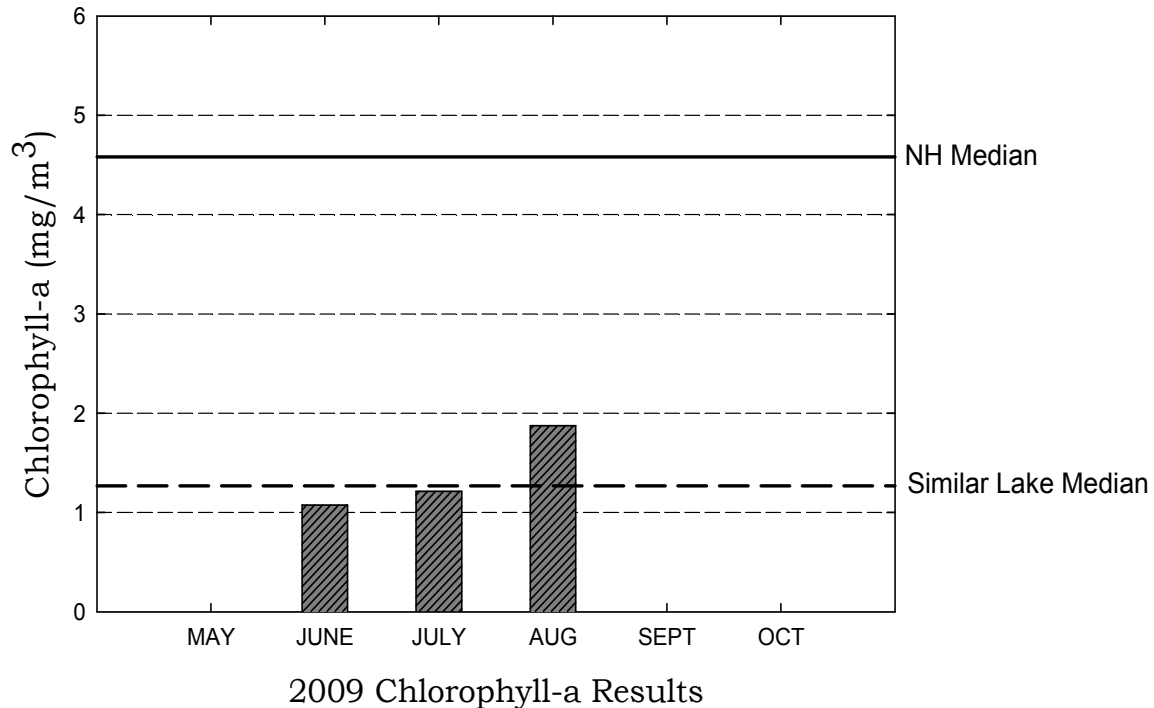
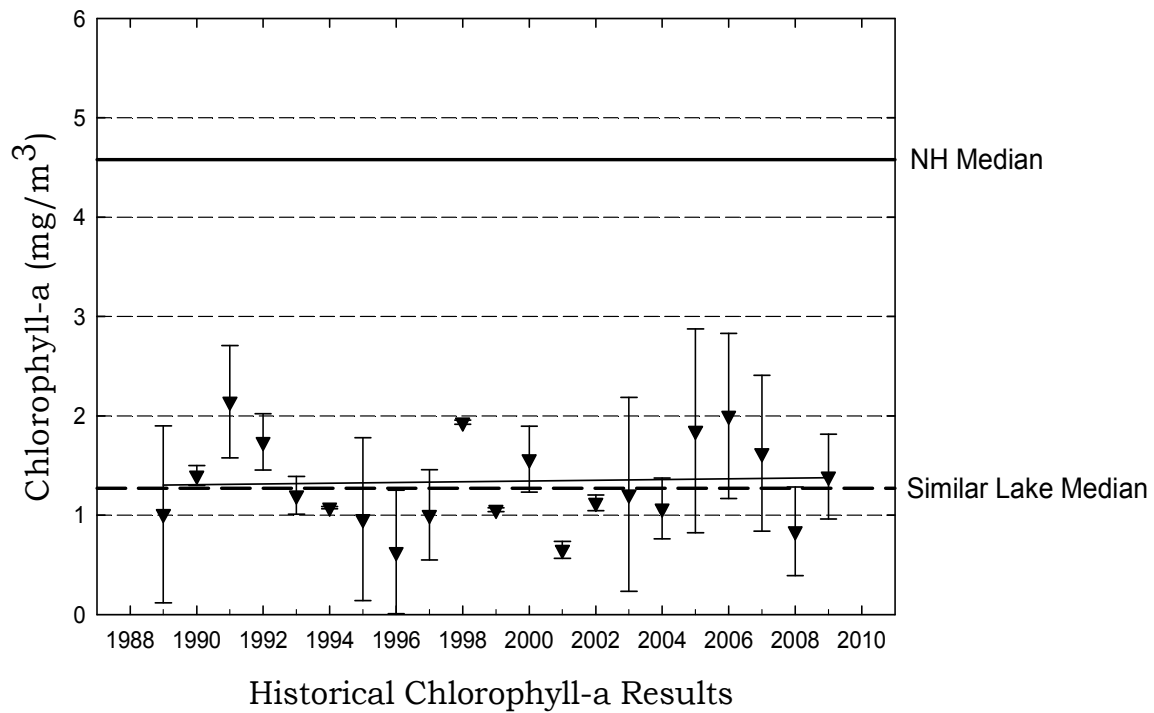
Figure 1. Monthly and Historical Chlorophyll-a Results

Figure 1 depicts the historical and current year chlorophyll-a concentration in the water column.

The current year data (the top graph) show that the chlorophyll-a concentration **increased gradually** from **June** to **August**.

The historical data (the bottom graph) show that the **2009** chlorophyll-a mean is ***much less than*** the state median and is ***slightly greater than*** the similar lake median. For more information on the similar lake median, refer to Appendix D.

Overall, visual inspection of the historical data trend line (the bottom graph) shows a ***relatively stable*** in-lake chlorophyll-a trend since monitoring began. Specifically the mean chlorophyll concentration has ***remained approximately the same*** since **1989**.

Therefore, it is extremely important for volunteer monitors to continually educate all watershed residents about management practices that can be implemented to minimize phosphorus loading to surface waters.

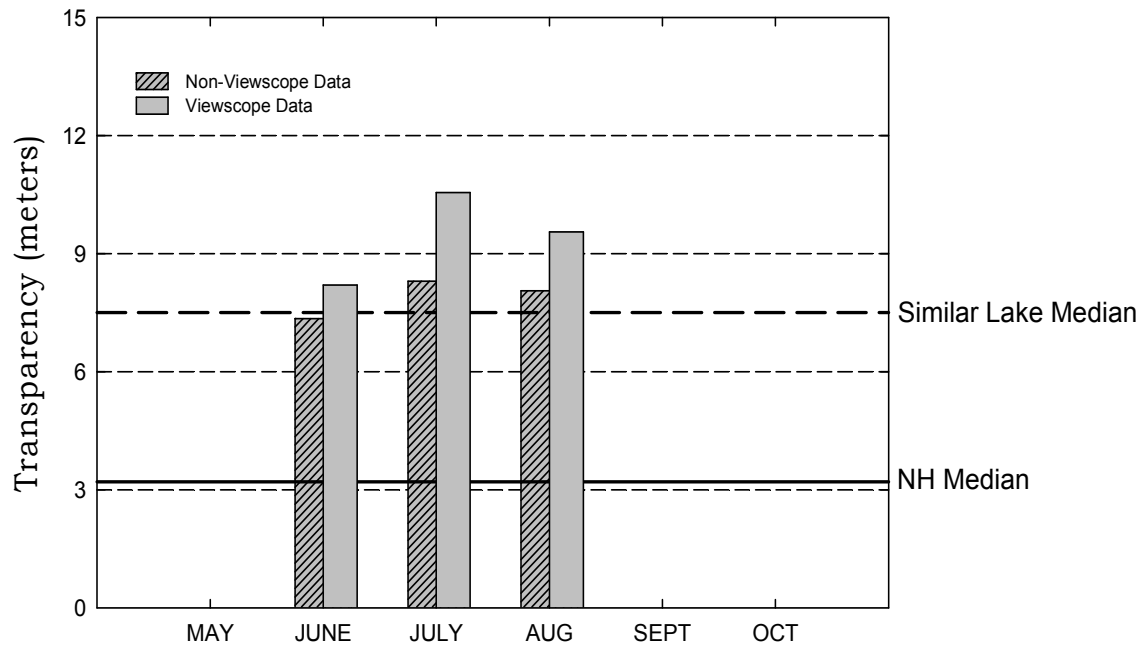
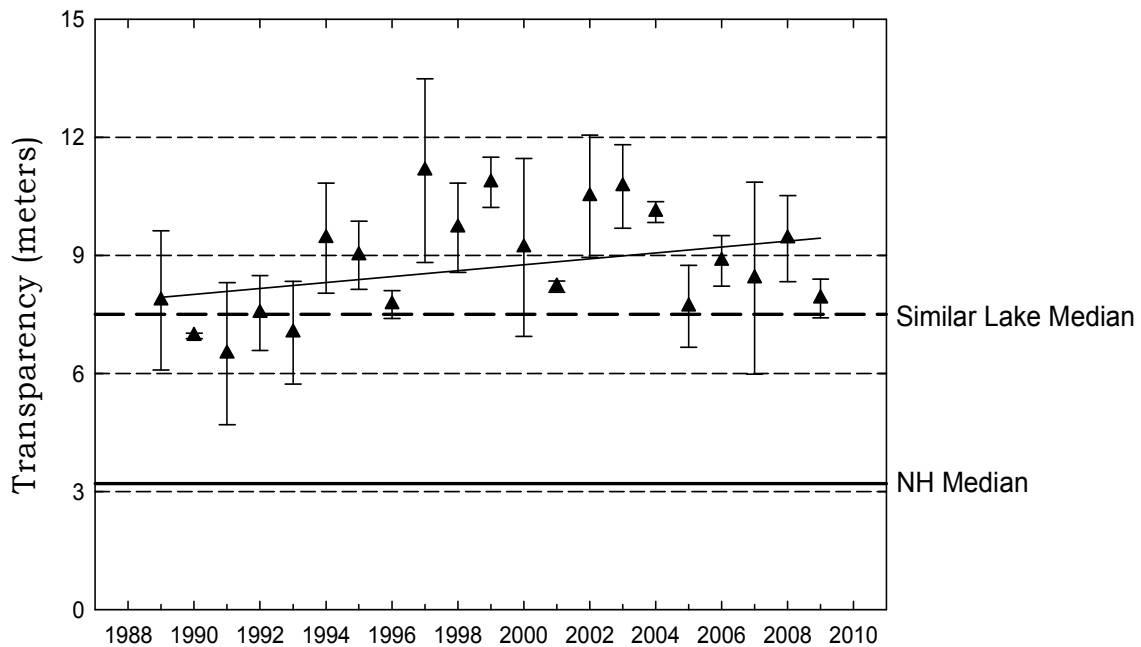
Figure 2. Monthly and Historical Transparency Results

Figure 2 depicts the historical and current year transparency *with and without* the use of a viewscope.

The current year *non-viewscope* in-lake transparency *increased* from **June** to **July**, and then *decreased slightly* from **July** to **August**.

The current year *viewscope* in-lake transparency *increased* from **June** to **July** and then *decreased* from **July** to **August**.

The transparency measured with the viewscope was generally *greater than* the transparency measured without the viewscope this summer. A comparison of the transparency readings taken with and without the use of a viewscope shows that the viewscope typically increases the depth to which the Secchi disk can be seen into the lake, particularly on sunny and windy days. We recommend that your group measure Secchi disk transparency with and without the viewscope on each sampling event.

The historical data (the bottom graph) show that the **2009** mean non-viewscope transparency is ***much greater than*** the state median and is ***slightly greater than*** the similar lake median. Please refer to Appendix D for more information about the similar lake median.

Visual inspection of the historical data trend line (the bottom graph) shows an ***increasing*** trend, meaning that the transparency has ***improved*** since monitoring began in **1989**.

We recommend that your group continue to measure the transparency with and without the use of the viewscope on each sampling event. Ultimately, we would like all monitoring groups to use a viewscope to take Secchi disk readings as the use of the viewscope results in less variability in transparency readings between monitors and sampling events. At some point in the future, when we have sufficient data to determine a statistical relationship between transparency readings collected with and without the use of a viewscope, it may only be necessary to collect transparency readings with the use of a viewscope.

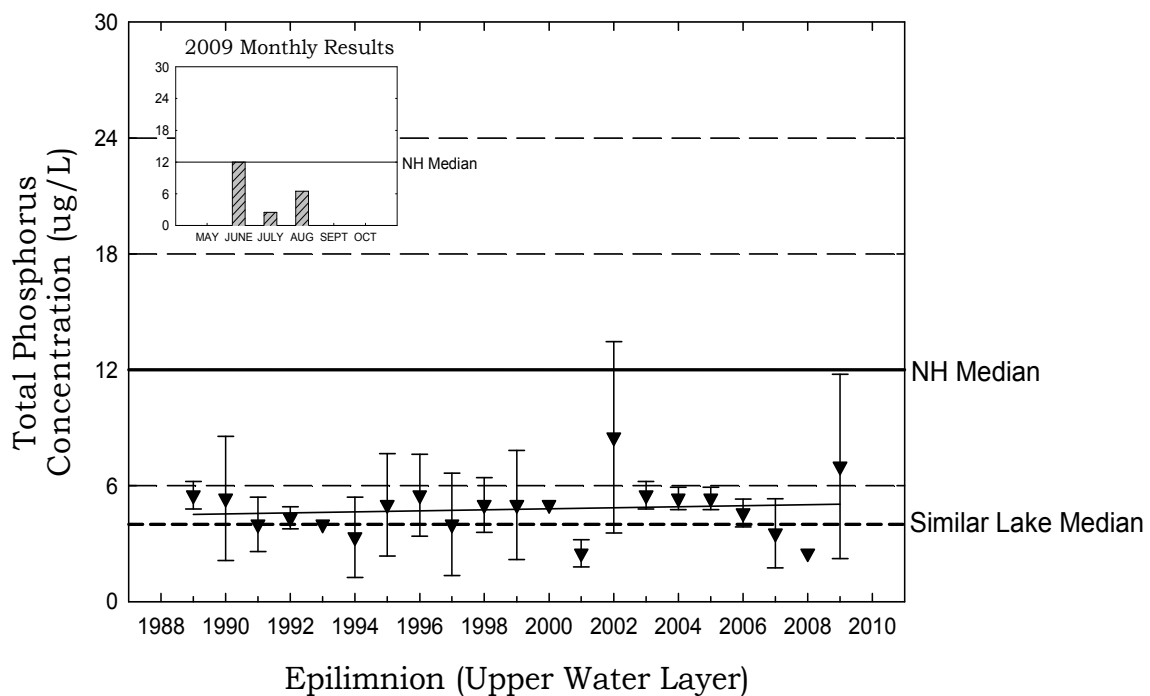
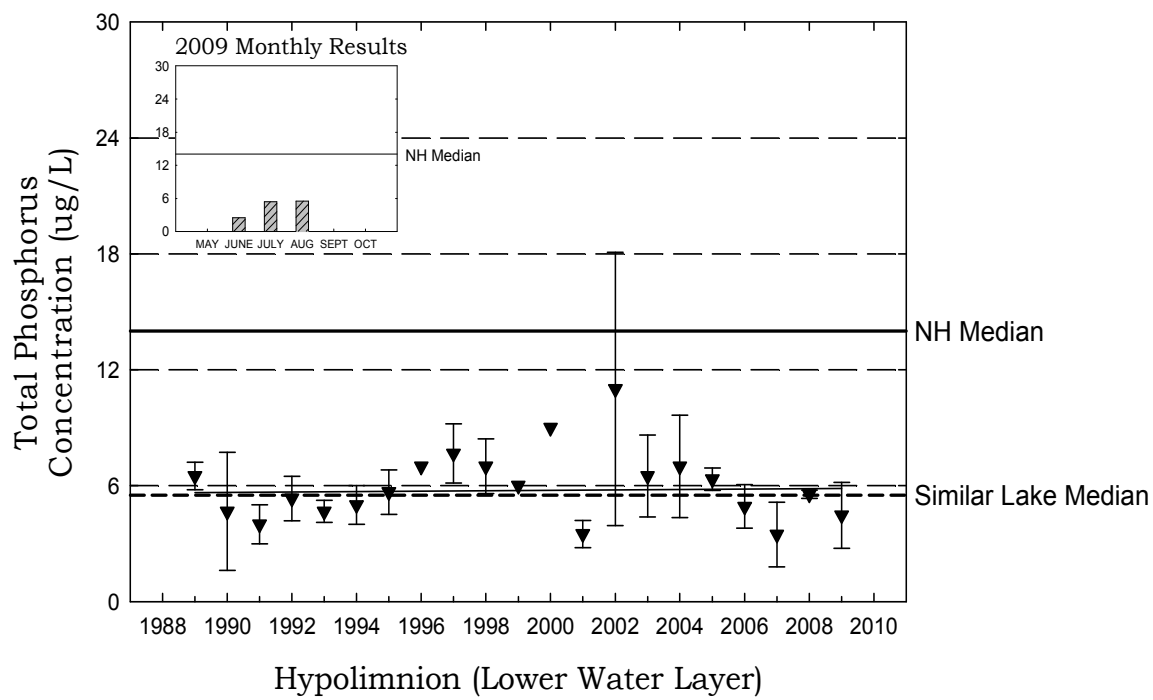
Figure 3. Monthly and Historical Total Phosphorus Data

The graphs in Figure 3 depict the historical amount of epilimnetic (upper layer) and hypolimnetic (lower layer) total phosphorus concentrations; the inset graphs depict current year total phosphorus data.

The current year data for the epilimnion (the top inset graph) show that the phosphorus concentration **decreased greatly** from **June** to **July**, and then **increased** from **July** to **August**.

The **elevated** epilimnetic phosphorus concentration measured on the **June** sampling event may have been due to phosphorus-enriched stormwater runoff that flowed into the surface layer of the lake. Weather records indicate that approximately rainfall while sampling and in the **24 hours** prior to sampling.

The historical data show that the **2009** mean epilimnetic phosphorus concentration is **less than** the state median and is **greater than** the similar lake median. Refer to Appendix D for more information about the similar lake median.

The current year data for the hypolimnion (the bottom inset graph) show that the phosphorus concentration **increased** from **June** to **July**, and then **remained stable** from **July** to **August**.

The historical data show that the **2009** mean hypolimnetic phosphorus concentration is **much less than** the state median and is **slightly less than** the similar lake median. Please refer to Appendix D for more information about the similar lake median.

Overall, visual inspection of the epilimnetic historical data trend line shows a **relatively stable** phosphorus trend. Specifically, the mean annual epilimnetic phosphorus concentration has **remained approximately the same** since monitoring began in **1989**.

Overall, visual inspection of the hypolimnetic historical data trend line shows a **slightly variable** phosphorus trend since monitoring began. Specifically the mean annual concentration has **fluctuated between approximately 3 and 11 ug/L** since monitoring began in **1989**.

One of the most important approaches to reducing phosphorus loading to a waterbody is to continually educate watershed residents about the watershed sources of phosphorus and how excessive phosphorus loading can negatively affect the ecology and the recreational, economical, and ecological value of lakes and ponds.
